Intel[®] 82443MX PCIset Specification Update

Release Date: August 2000

The 82443MX PCIset may contain design defects or errors known as errata that may cause the product to deviate from published specifications. Current characterized errata are documented in this Specification Update.

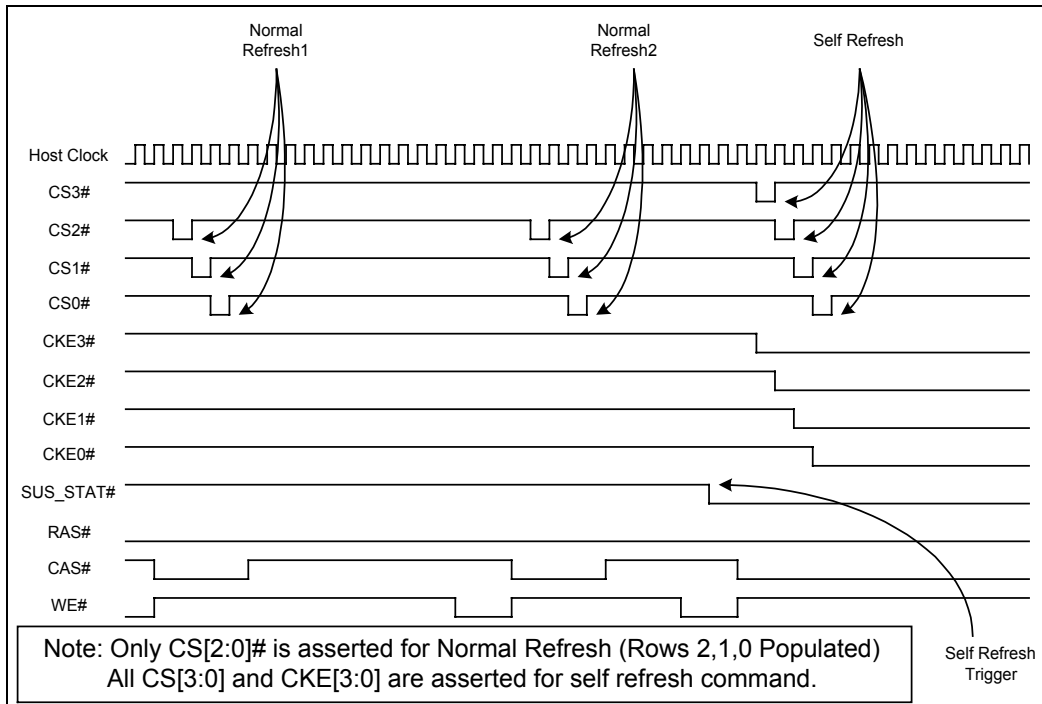
Figure 1: Successful Self-refresh Entry

Figure 1 illustrates a successful suspend entry sequence for a system which has rows 0, 1, and 2 populated. Note that for normal refresh, only the chip selects for the populated rows are asserted, whereas for the self-entry command, all four chip selects are asserted regardless of its population. Assume that dynamic SDRAM power-down feature is disabled. If all four rows are populated, it is impossible to capture this erratum.

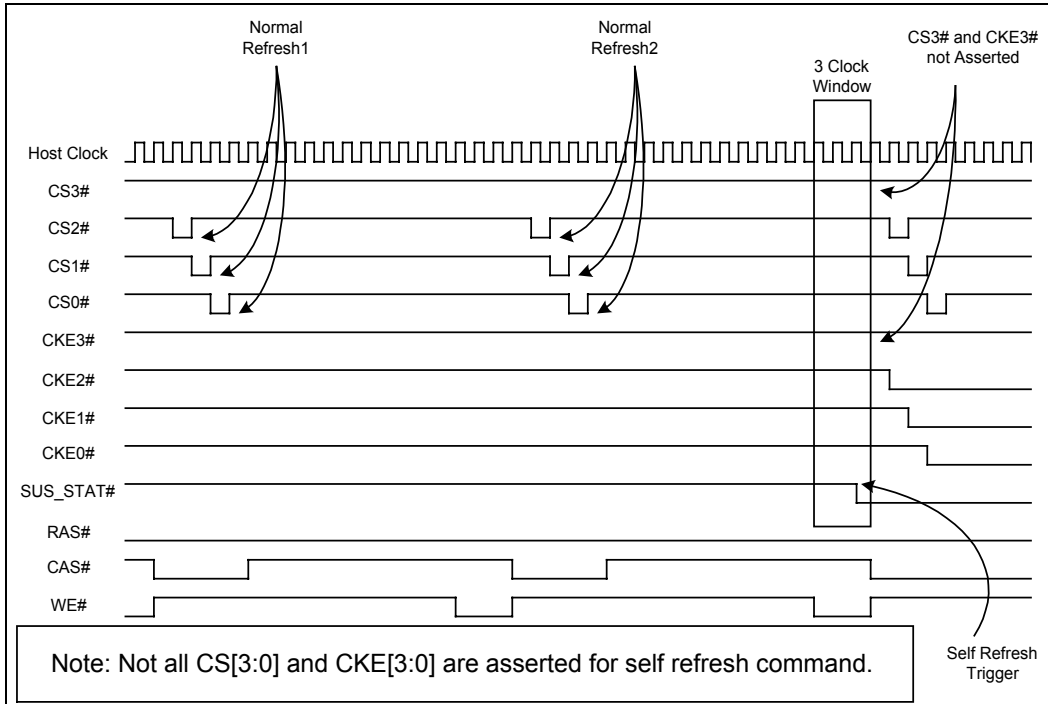
Figure 2: Unsuccessful Self-refresh Entry

Figure 2 illustrates an unsuccessful self-refresh entry sequence. Note that SUS_STAT# is being asserted approximately the same time that the third normal refresh would have taken place. Since the SUS_STAT# assertion hits the three host clock window, CS3# and CKE3# do not get asserted during the self-refresh entry sequence.

IMPLICATION: The system may hang if an unsuccessful self refresh entry sequence occurs.

WORKAROUND: Please refer to the SDRAM Suspend Refresh Erratum APM Workaround Write-up, Rev 1.0 for a software workaround solution.
