Intel[®] StrongARM^{*} SA-1110 Microprocessor

Specification Update

December 2000

Order Number: 278259-020

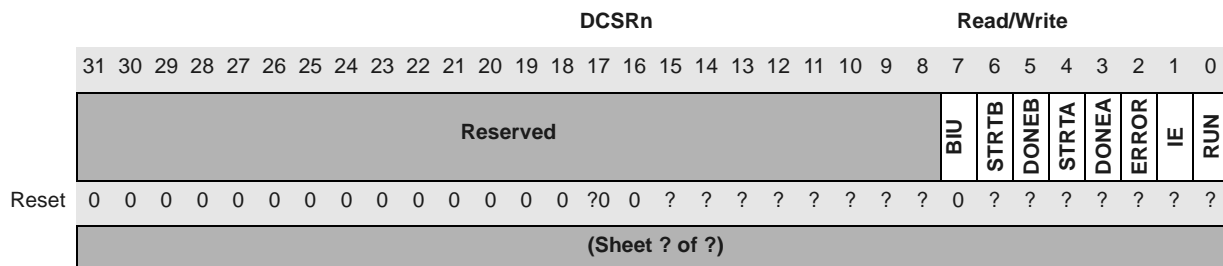
27. **DMA Control/Status Register (DCSRn): Section 11.6.1.2**

Changed DMA control/status register bit-0 from RUNE to RUN and changed the reset value of BIU (Bit 7) from "?" to "0".
