Intel[®] StrongARM^{*} SA-1110 Microprocessor

Specification Update

April 2001

Order Number: 278259-022

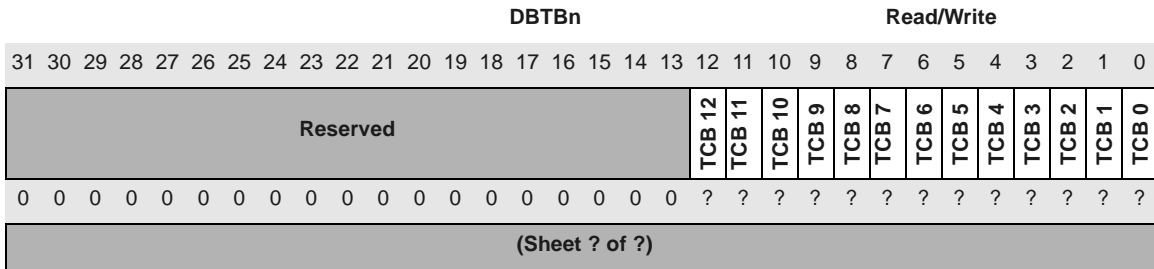
58. DMA Buffer B Transfer Count Register (DBTBn): Section 11.6.1.6

Changed DMA Buffer B Transfer Count register reset values for the Reserved bits to 0.

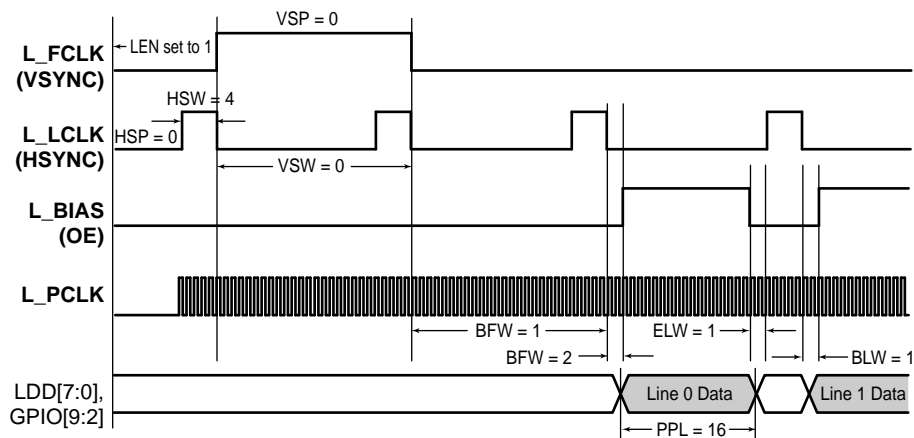
Figure 11-13. Active Mode Timing

Corrected Notes: in Figure 11-13 to show the range of PPL as 16 to 1024 (not 1 to 1024.) The corrected figure is shown below:
